ACCIDENT INVESTIGATION

Case No. 90-02

AIRBAG INVESTIGATION

NHTSA In-Depth Airbag Accident Investigation Case 90-02

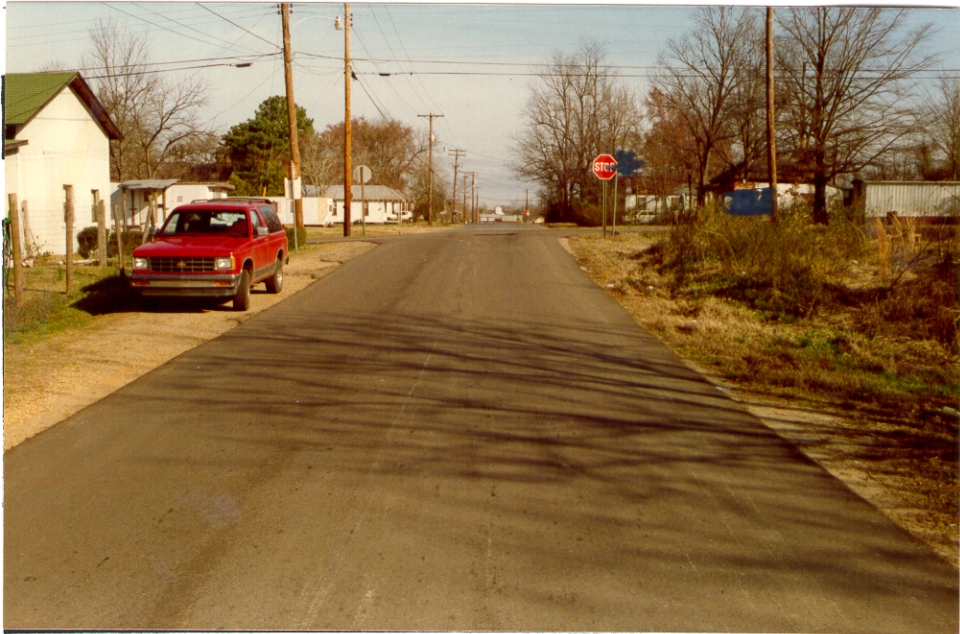
1. Pre-impact travel of the 1990 Dodge Spirit (airbag vehicle)\ north on [REDACTED] Street in [REDACTED] Arkansas.

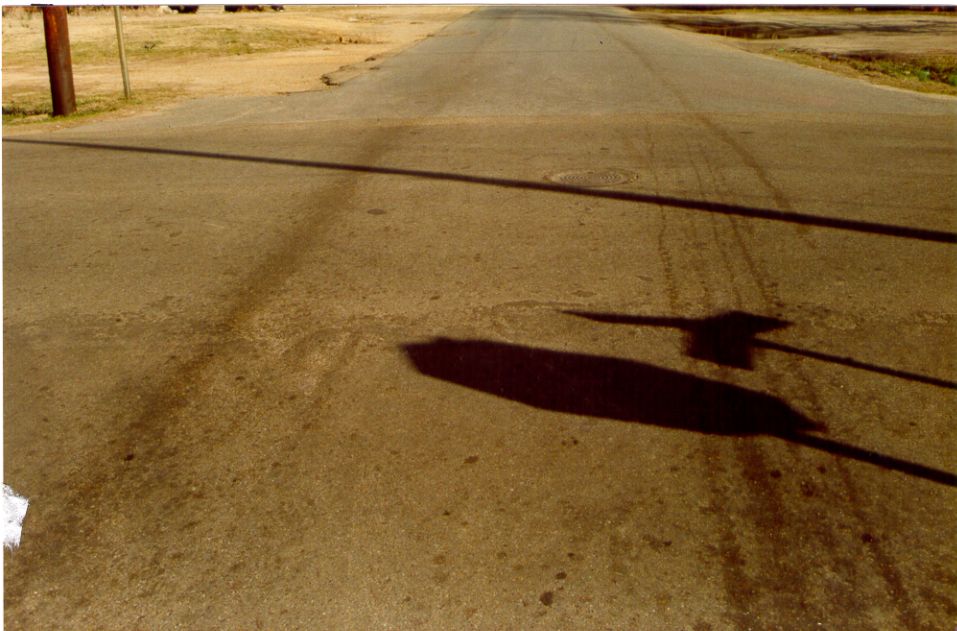
2. Area of impact of the Spirit with the 1979 Pontiac Grand Prix, and final rest area of the Spirit.

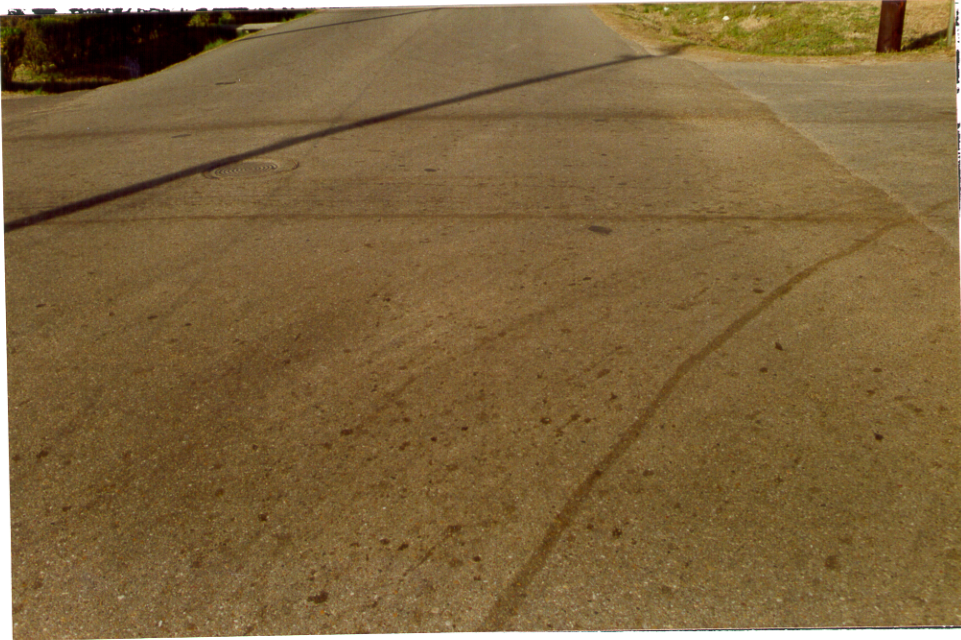
5. Area of impact looking west.

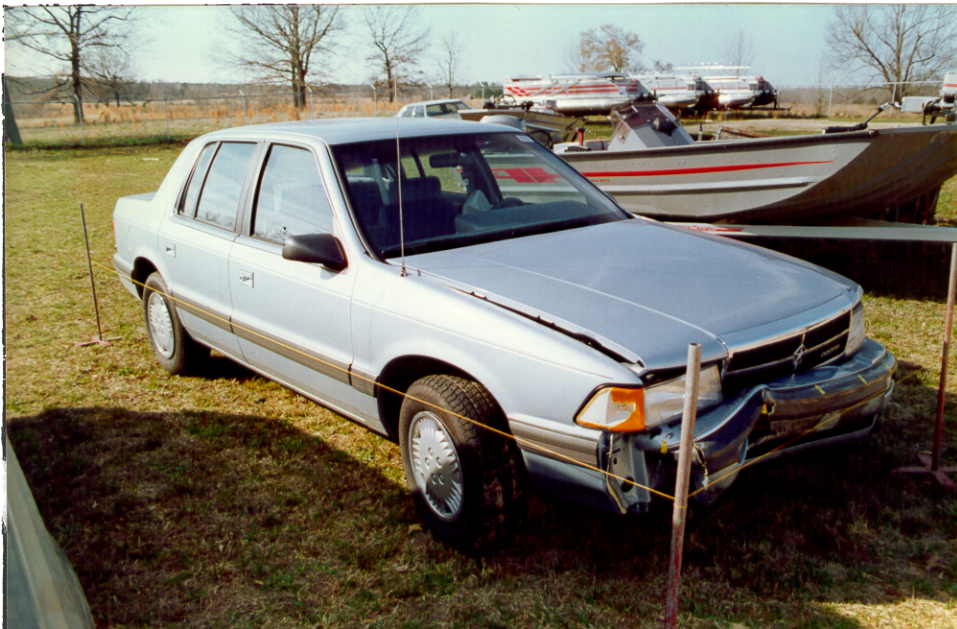
Damaged exterior components included the front bumper, grille, hood, right front fender, right front parking lamp.

6. Front-right overall view of the 1990 Dodge Spirit.

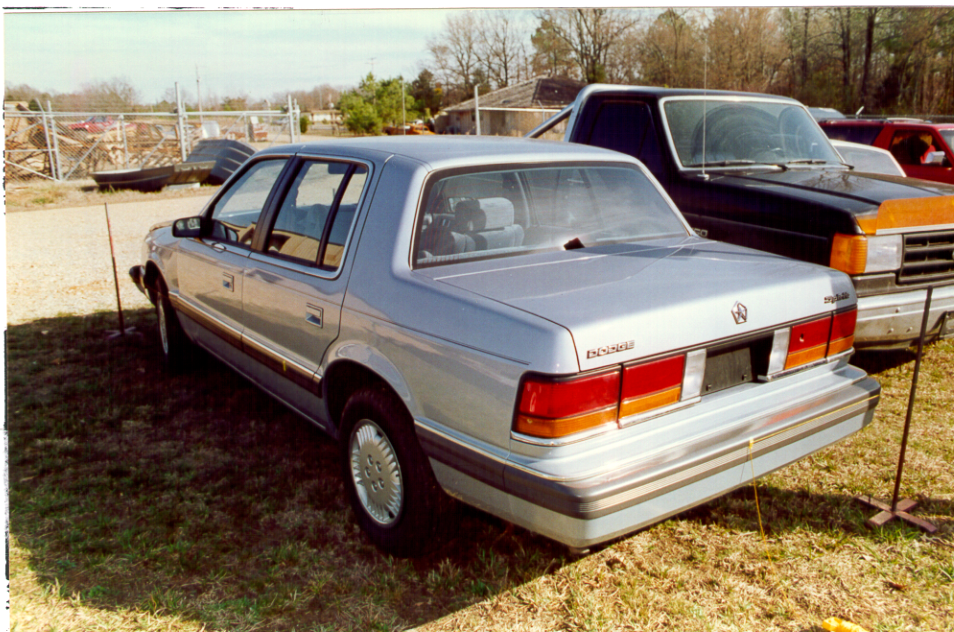
8. Rear-left overall view of the Spirit.

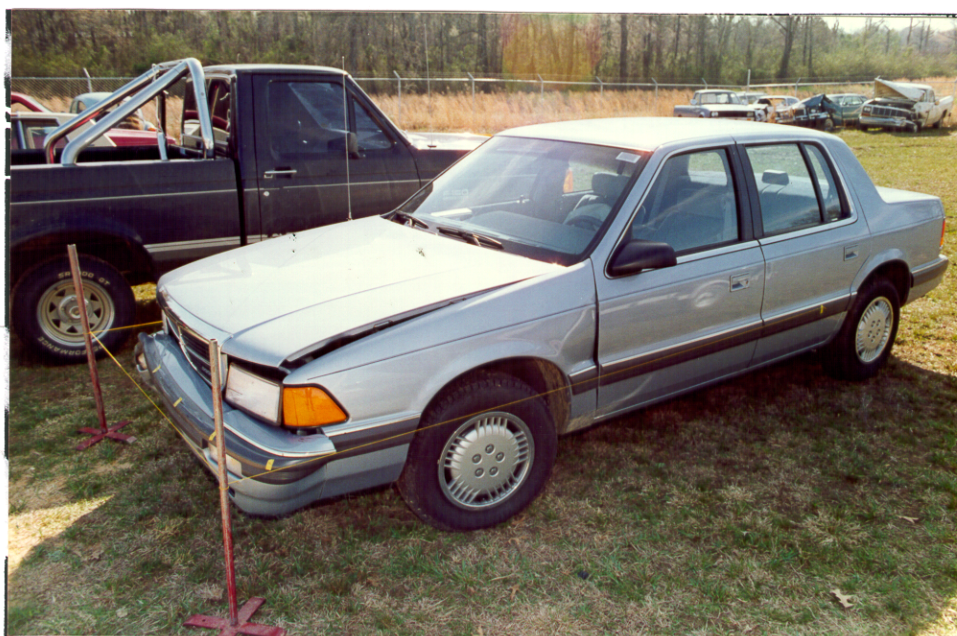
9. Front left overall view of the Spirit.

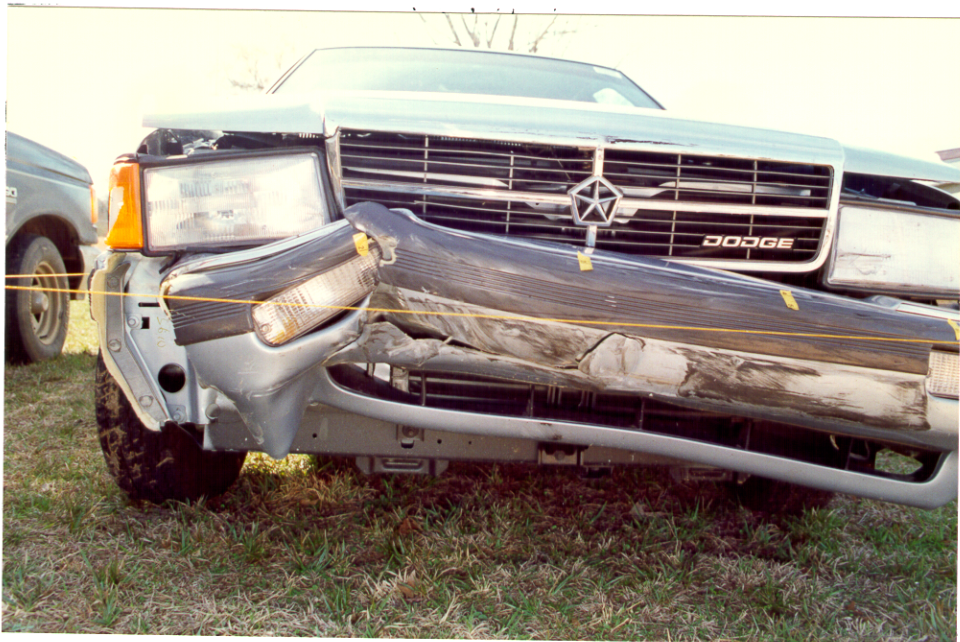
| | <u>Airbag Vehicle</u> | <u>Vehicle #2</u> |
|---|---|--|
| Exterior Damage: | <p>The frontal surface of the airbag vehicle impacted the left side of the Grand Prix in an angle impact. Direct damage extended across the entire frontal plane of the Spirit a distance of 55.0 inches. Crush measurements taken across the frontal plane were as follows:</p> <p>C1 = 1.0" C2 = 1.2" C3 = 1.6" C4 = 1.8" C5 = 3.8" C6 = 4.2"</p> | <p>The Grand Prix was struck in the left side by the frontal surface of the Spirit. Direct damage extended along the side of the vehicle for a distance of 97.0 inches and direct plus induced damage length was 115.0 inches. Crush measurements along the side plane were as follows:</p> <p>C1 = 0.0" C2 = 2.0" / Altered C3 = 4.0" / Altered C4 = 6.0" C5 = 0.8" C6 = 0.0"</p> |

10. Close-up view of frontal impact area.

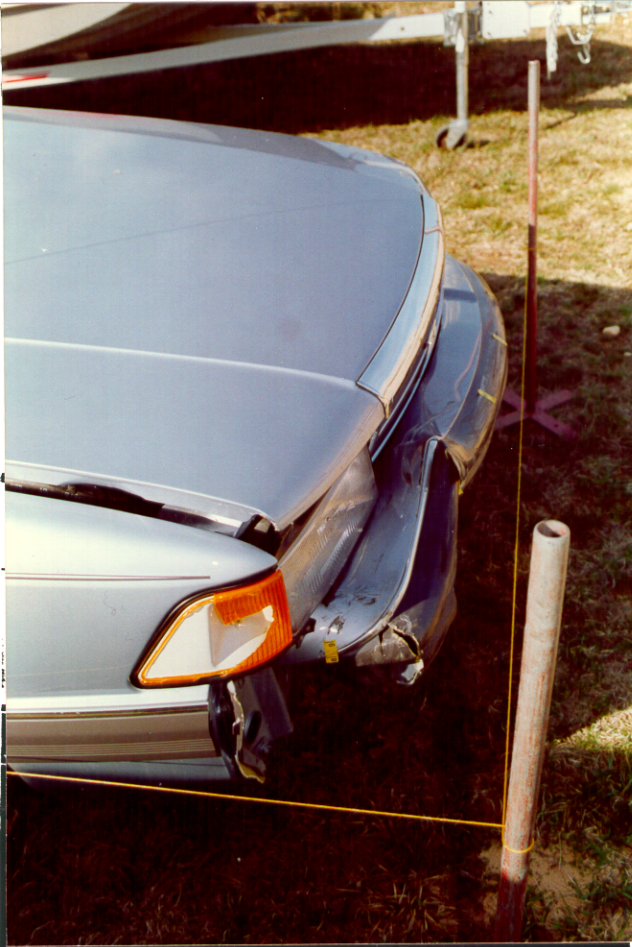
12-13. Views down front stringline showing rearward crush of the bumper.

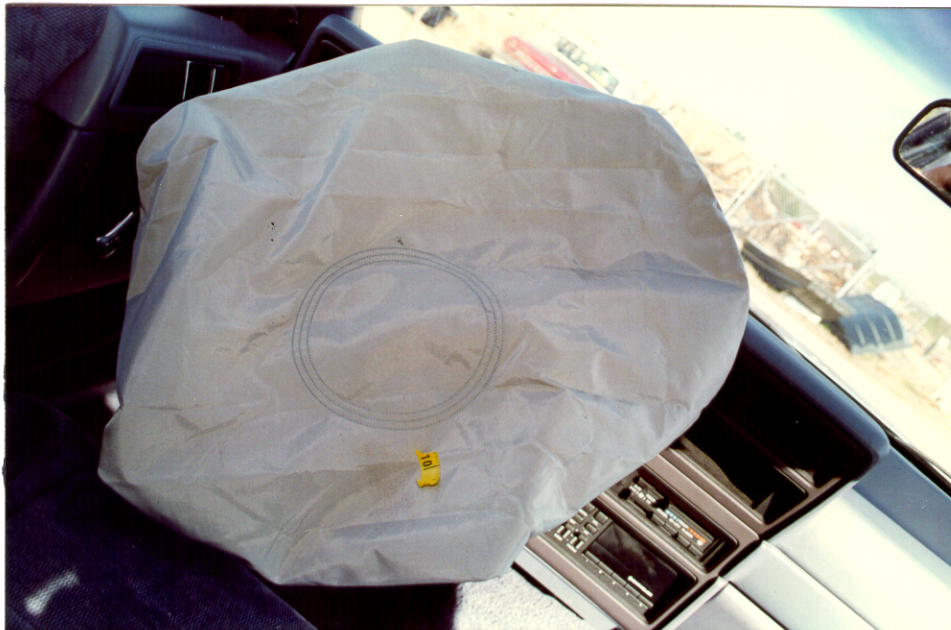
The driver's side airbag restraint system deployed as a result of the frontal impact. The driver responded to the impact force by moving forward and to the right relative to the vehicle interior, loading the deployed airbag module with her face and upper torso. She stated that she sustained a laceration of her inner upper lip from the impact force with the deployed airbag. Occupant contact to the airbag was noted during the inspection of the vehicle.

15. Overall view of deployed airbag showing occupant contact.

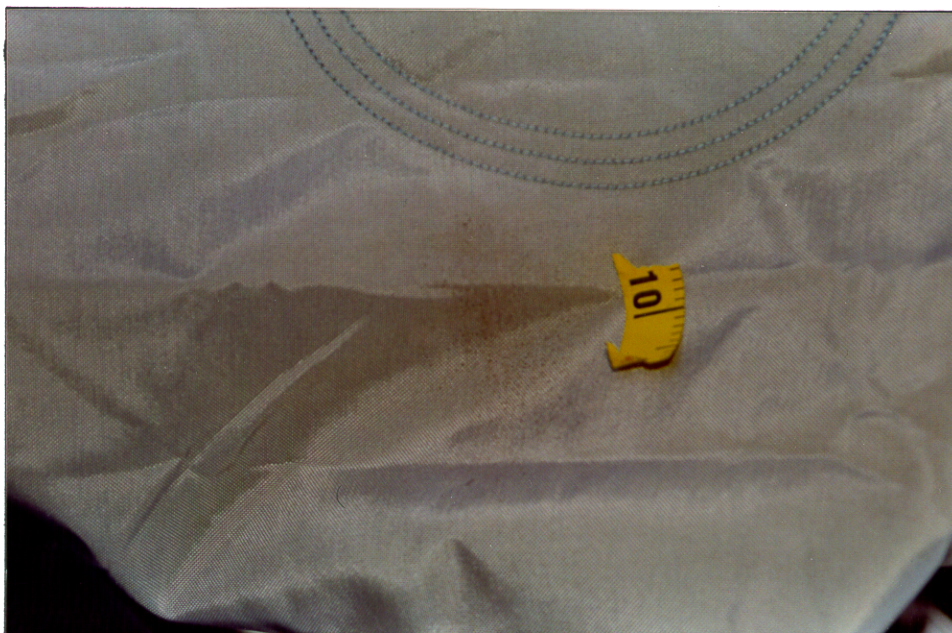
16. Close-up of occupant contact to the deployed airbag.

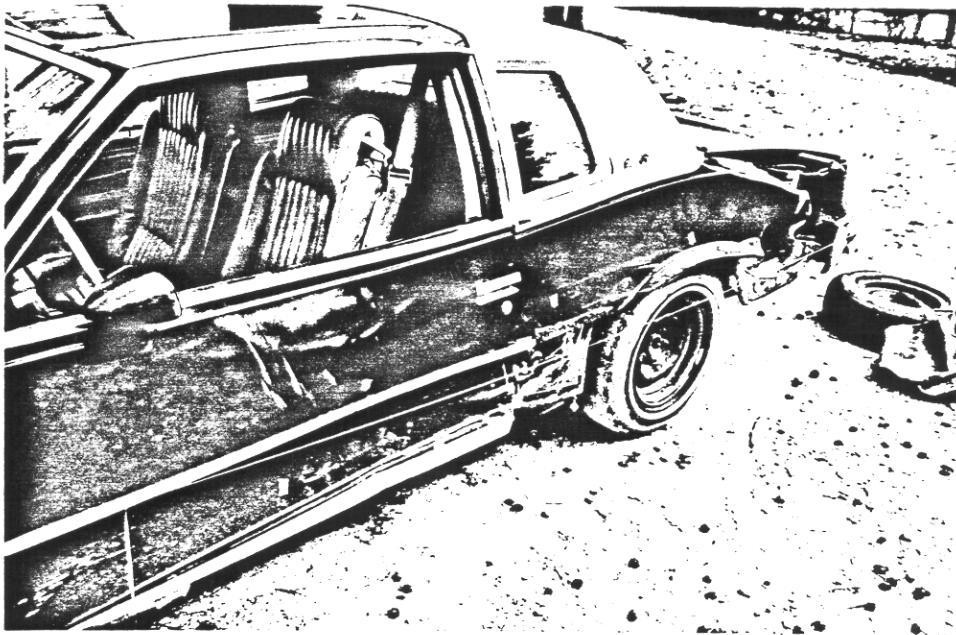
Damaged exterior components included left side door, left rear quarter panel, left rear wheel, and wheel cover.

19. Closeup view of damage to the Grand Prix.

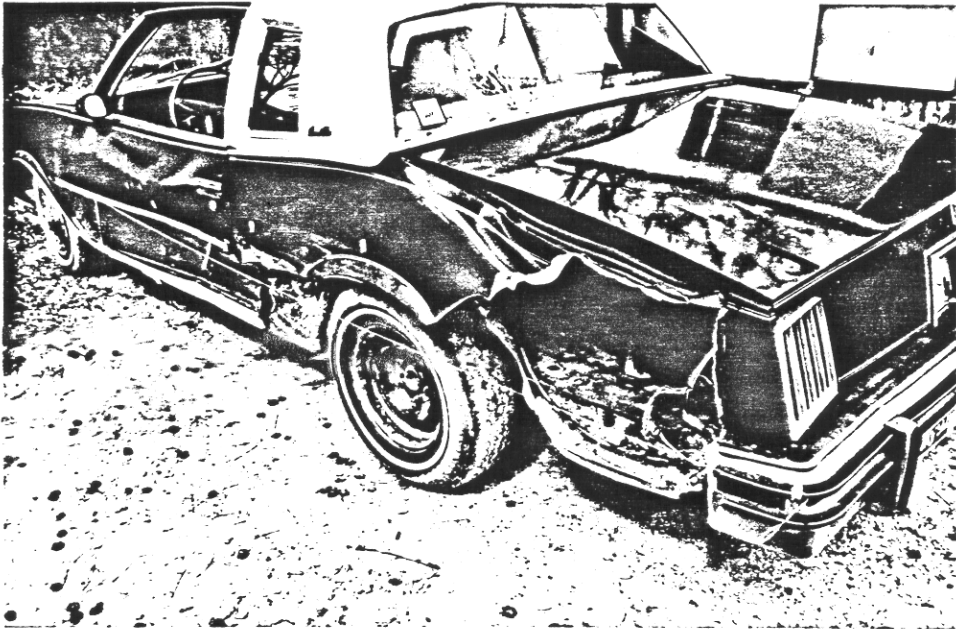
20. Additional close-up view of left side damage.
